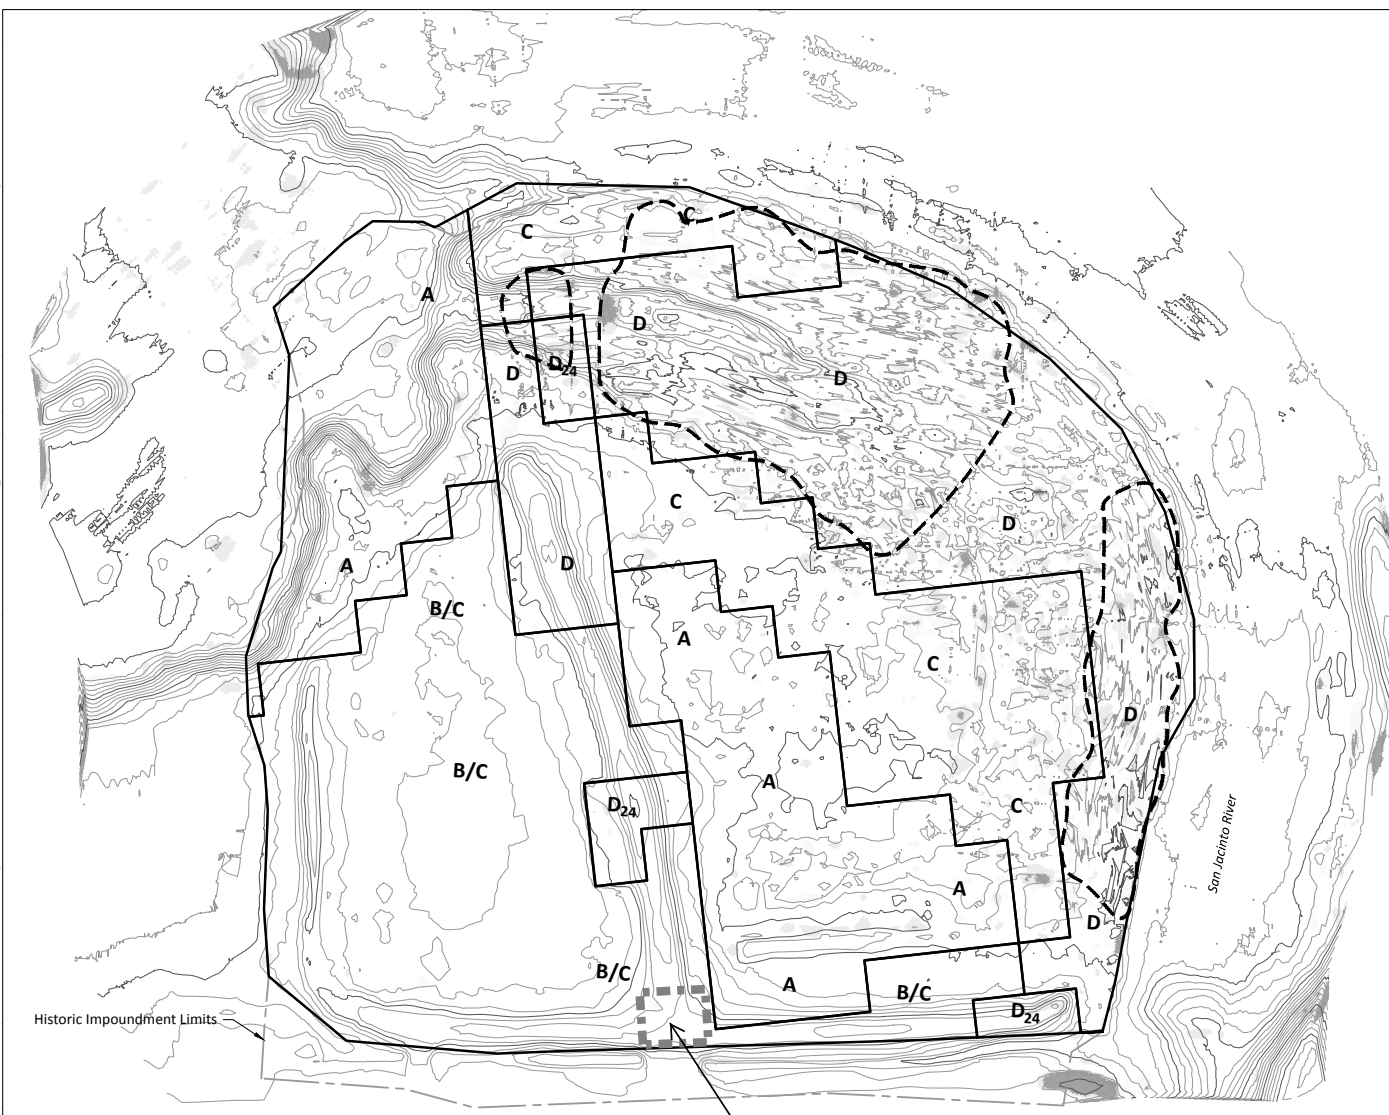
SOURCE: Drawing prepared from surveys provided by Hydrographic Consultants dated July 2014 and January 2015 and supplemented with additional survey data collected on April 8, 2015.
HORIZONTAL DATUM: Texas State Plane South Central, NAD83, U.S. Feet.
VERTICAL DATUM: NAVD 88.

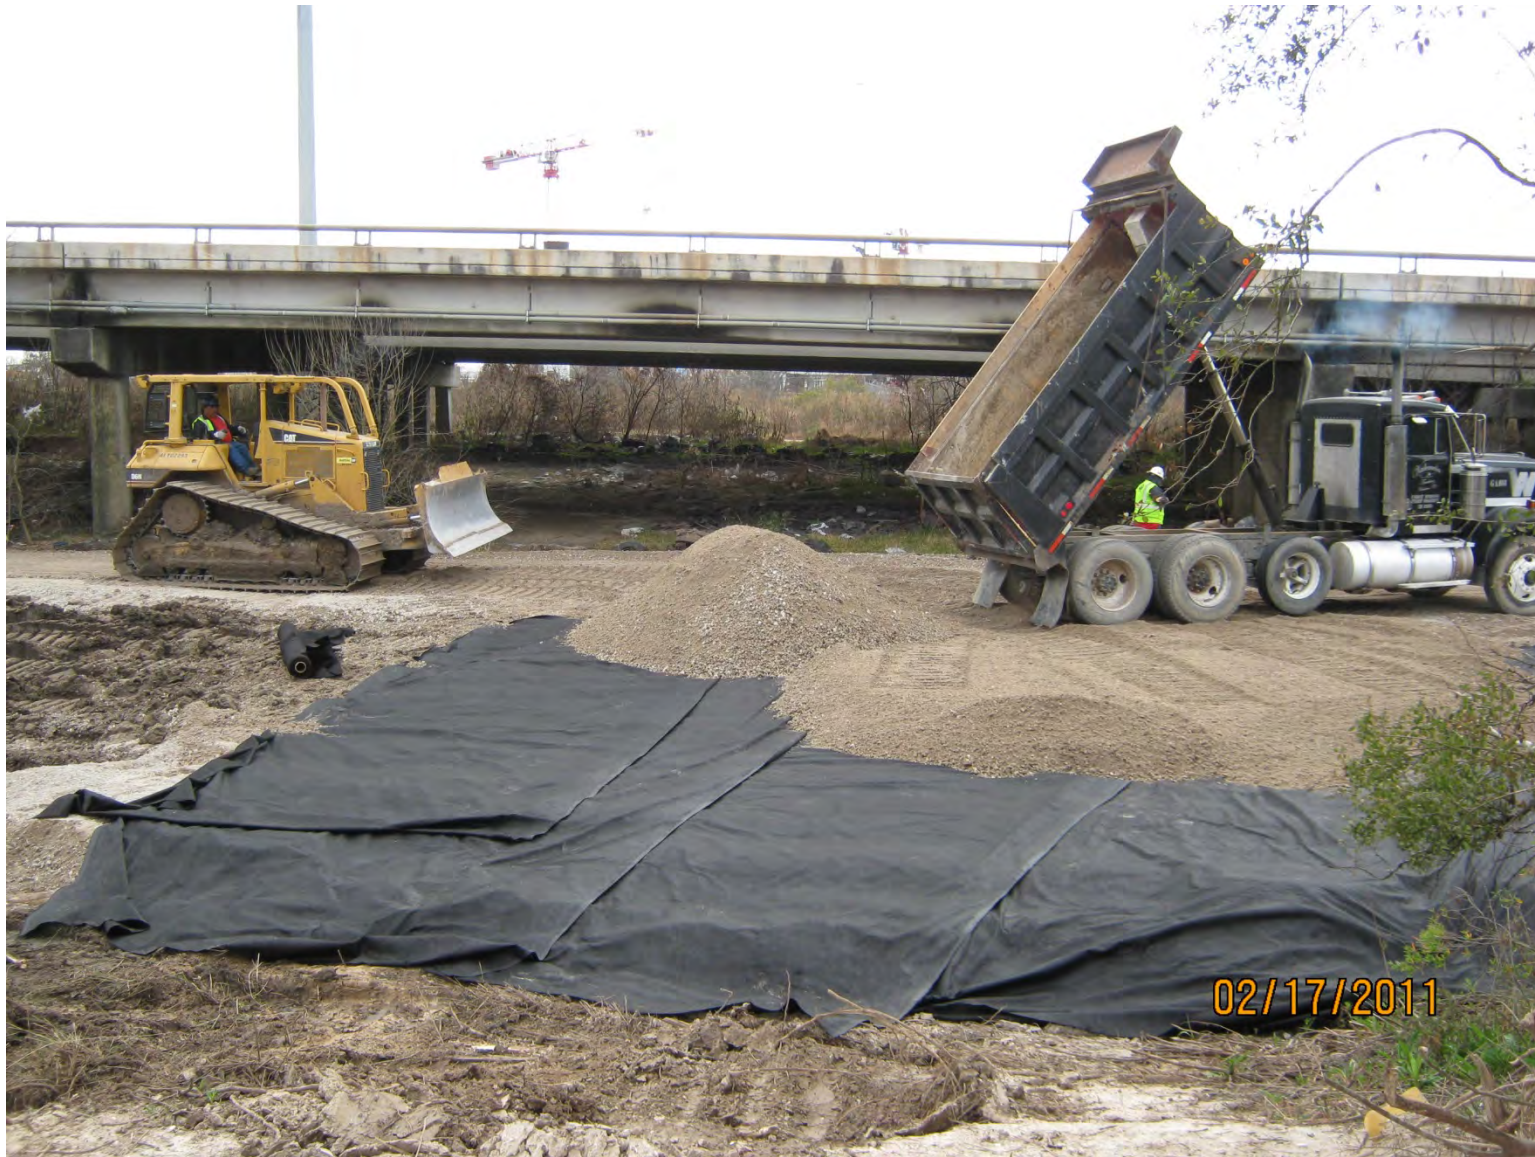
Constructing east ramp to stockpile area. Note multiple layers of geotextile are installed before crushed stone aggregate.

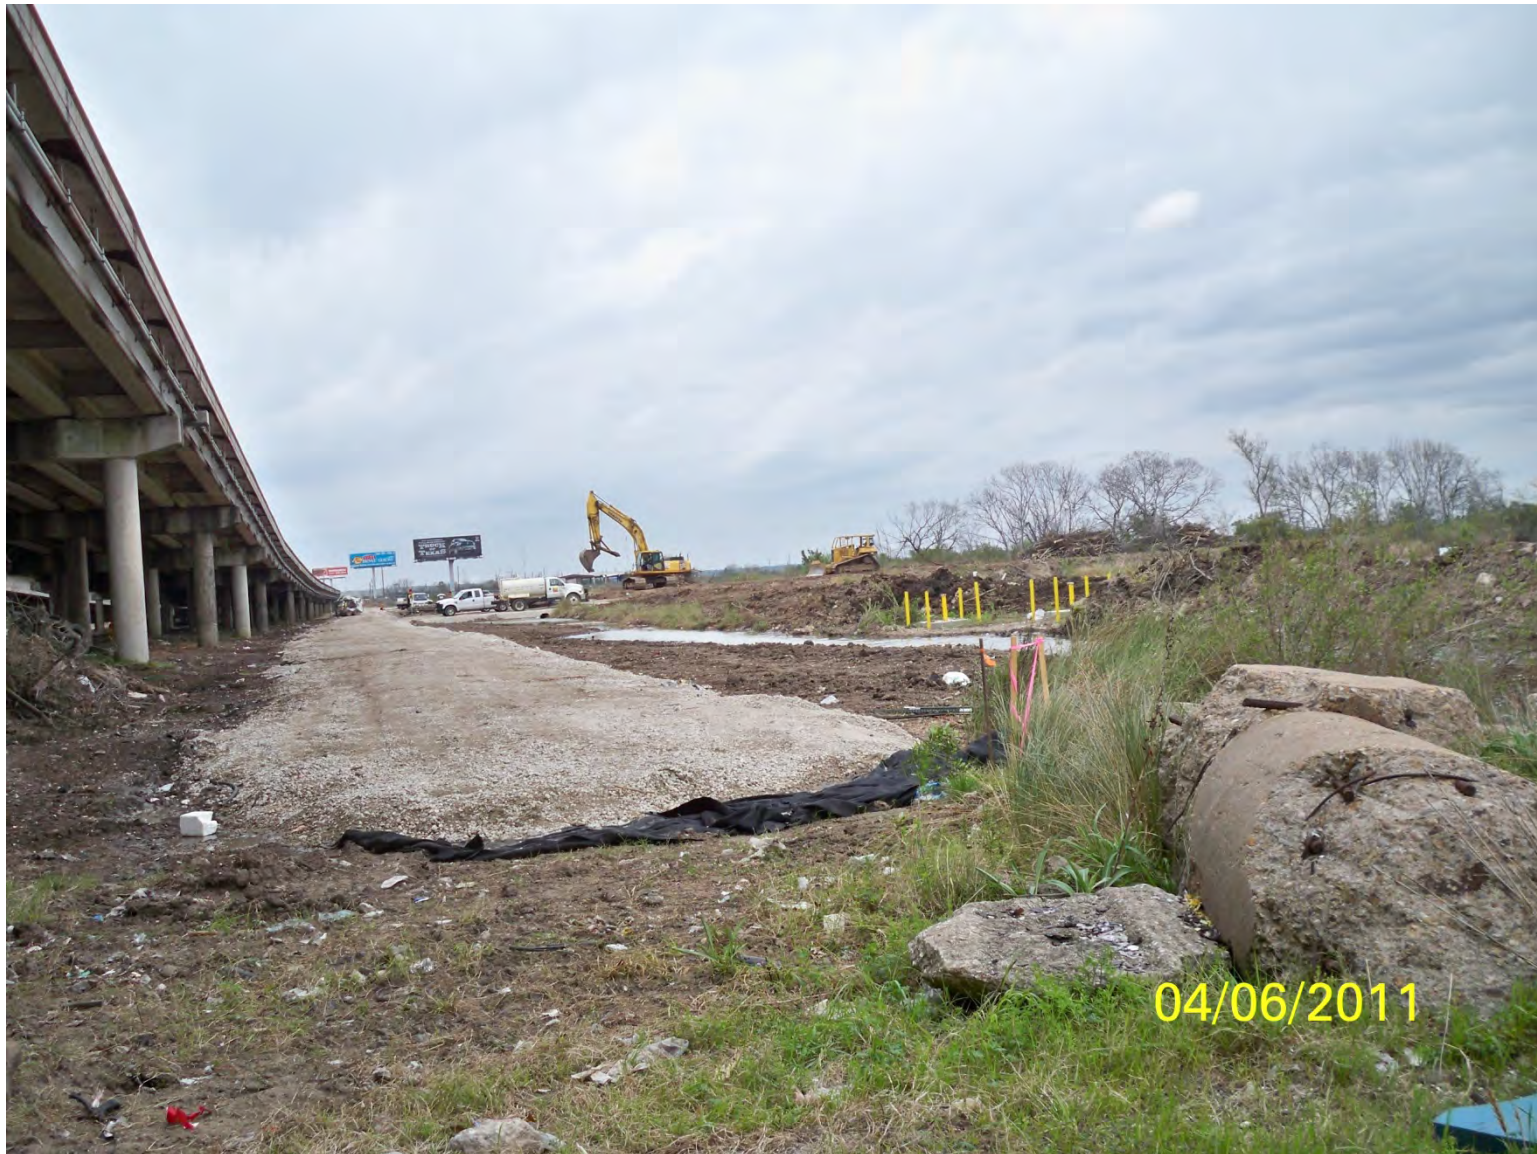
Working atop the stockpile area. Note geotextile under aggregate on the road.

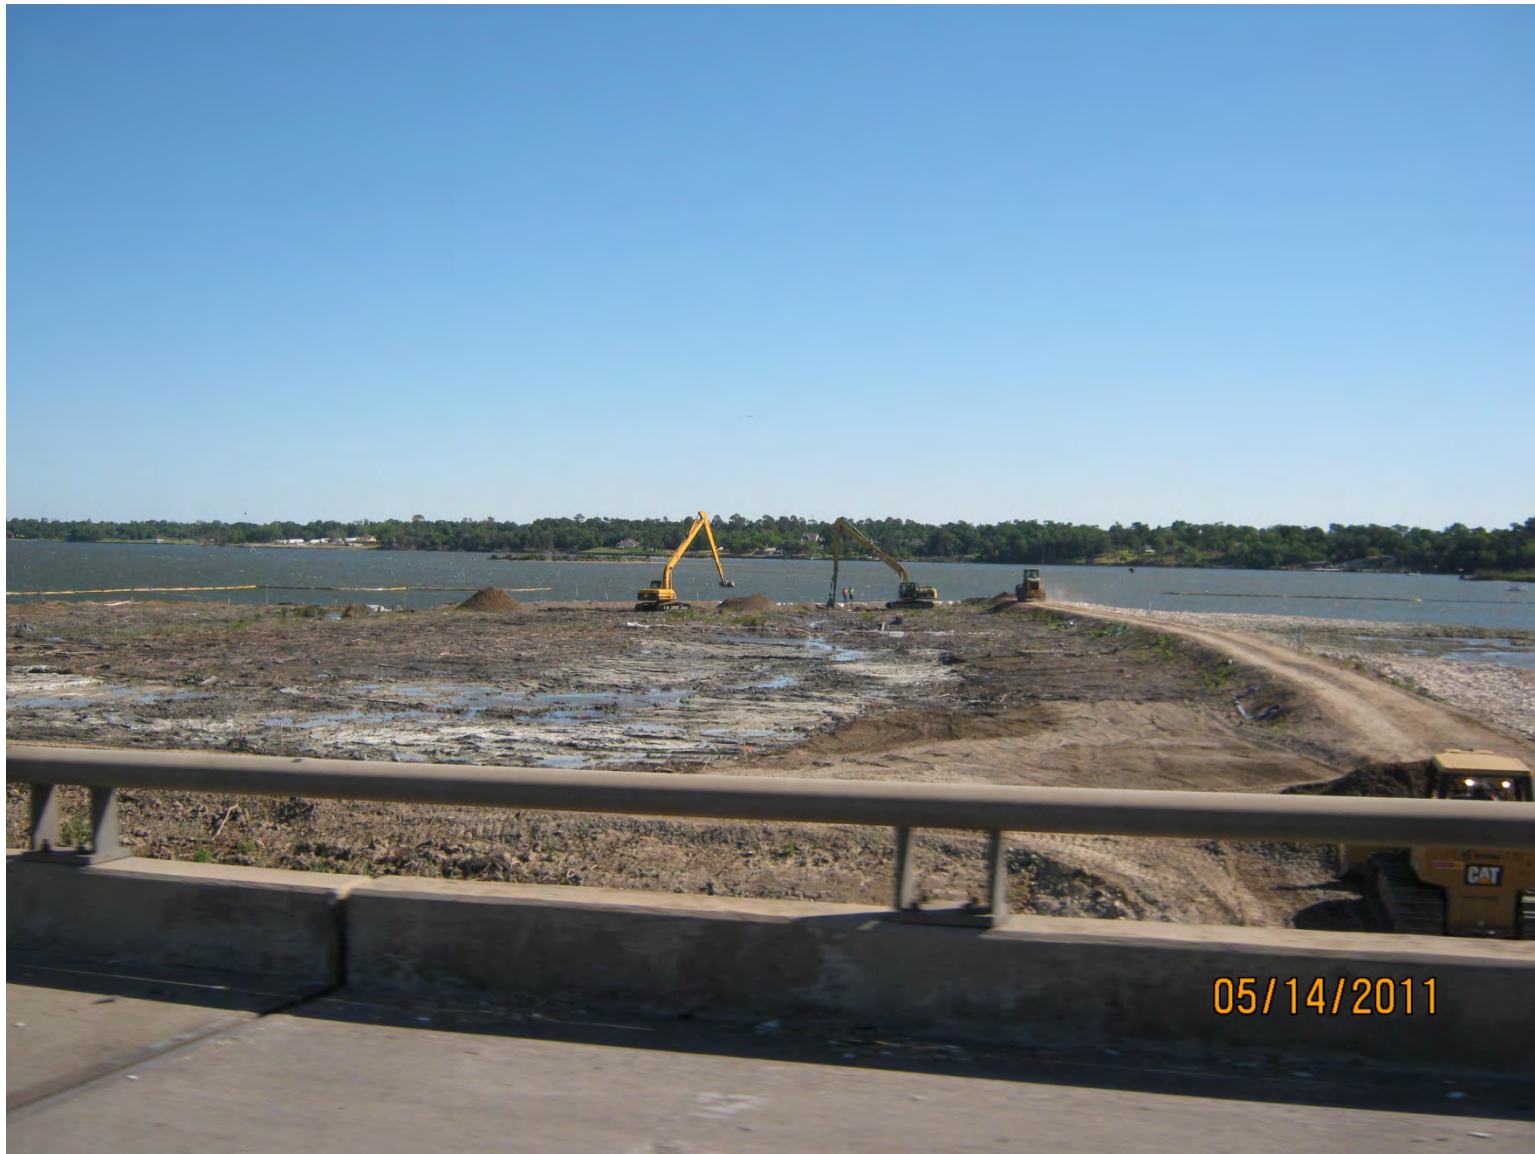
Photo from I-10 Bridge looking north along central berm. Note construction stockpile area aggregate and work pad installation

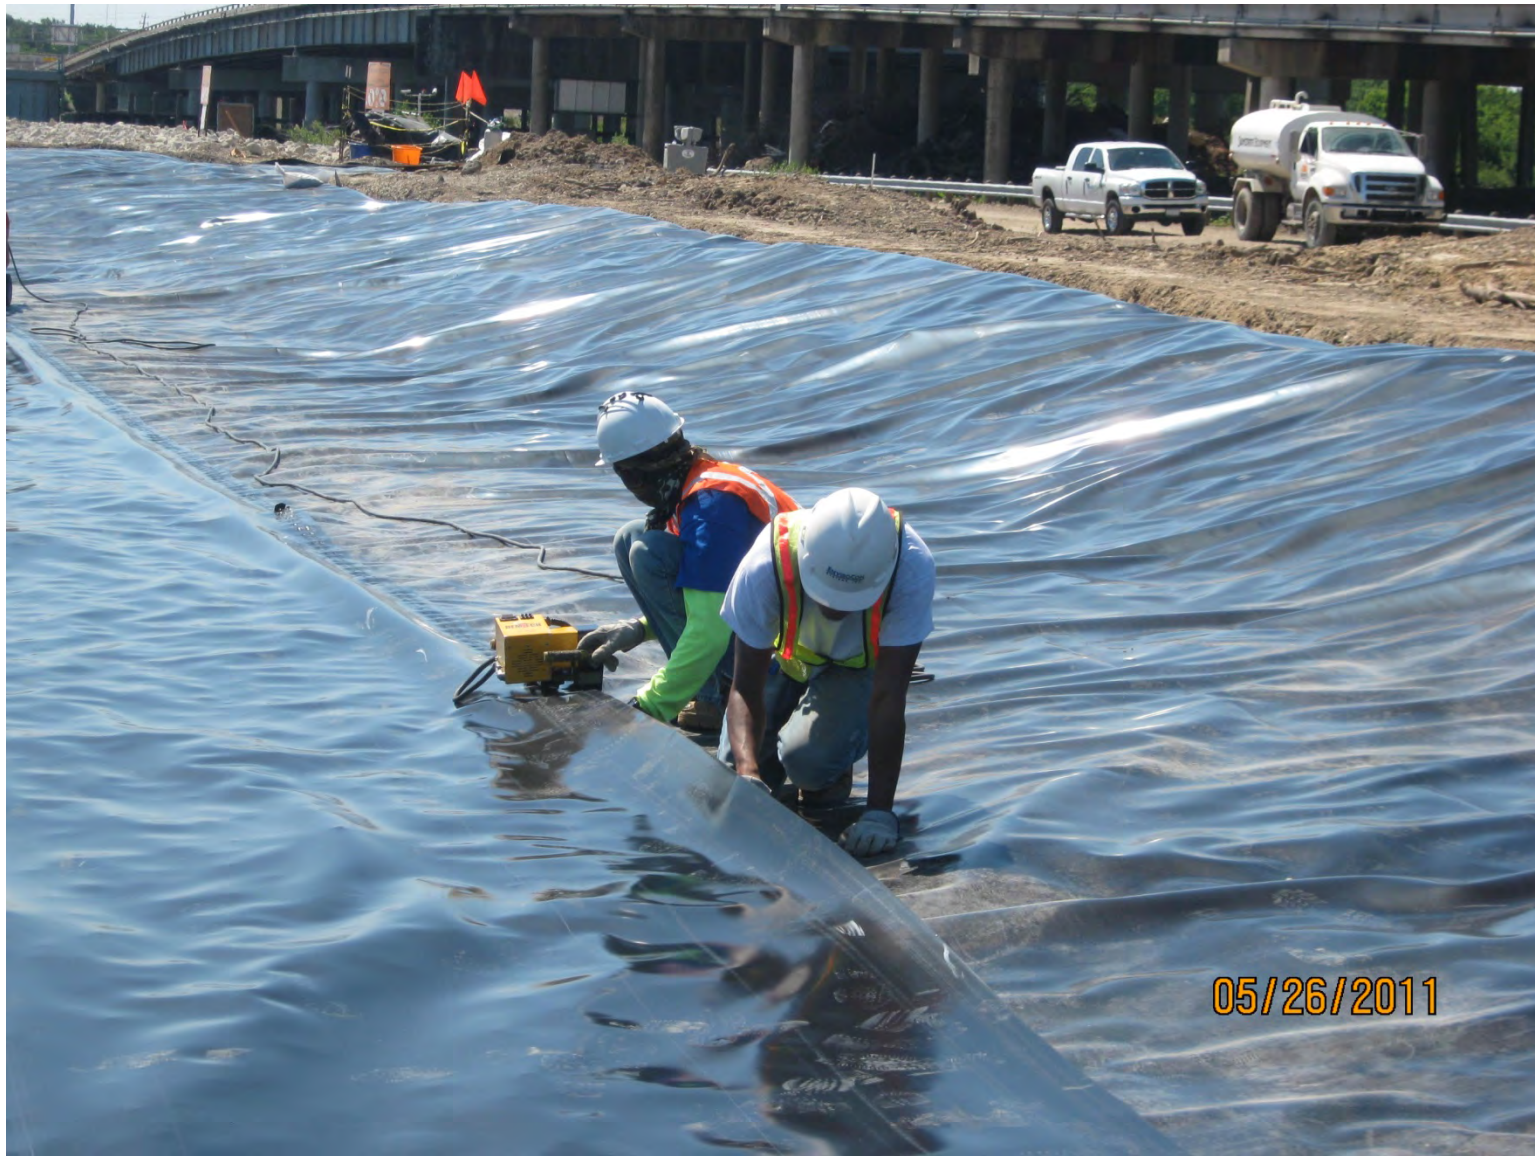
Seaming geomembrane. Looking east southeast at the intersection of the south and central berms and the stockpile area. Note geomembrane installed over a 12 ounce geotextile with edges buried in a trench.

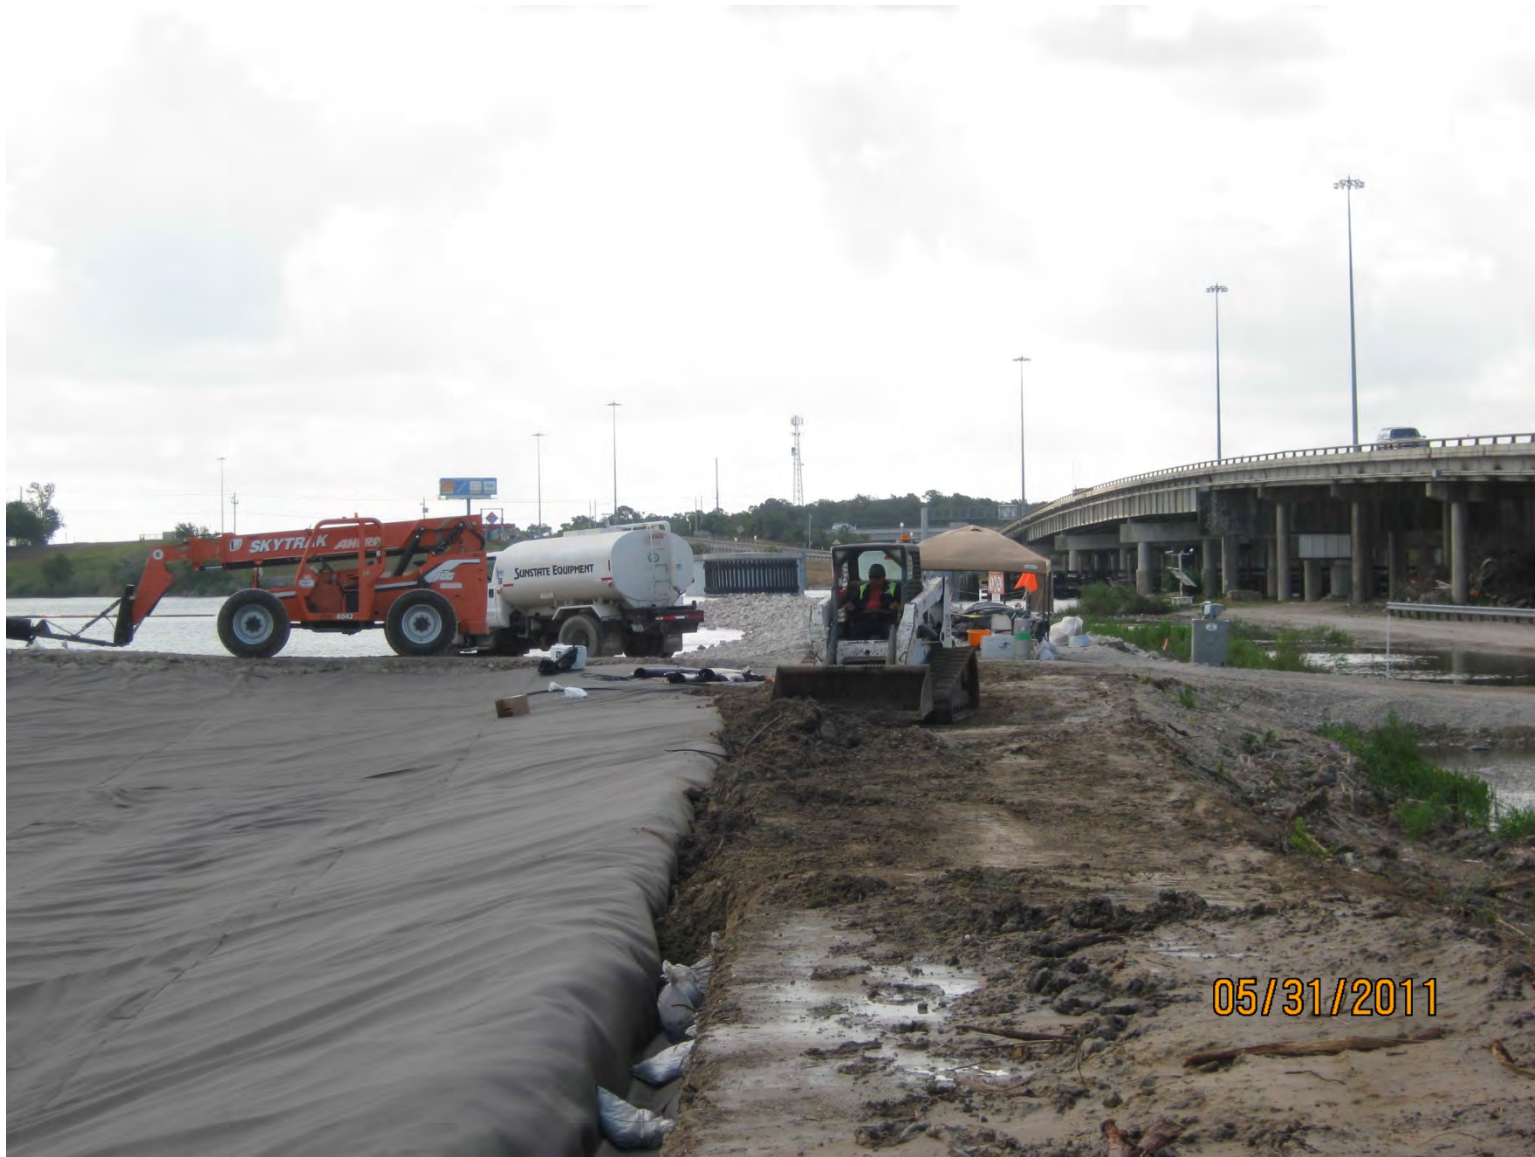
Standing atop south berm looking east at the stockpile area. Note fabric pulled into trench to anchor two layers of geotextile and geomembrane to the left and fabric fold to the right of the berm crest.

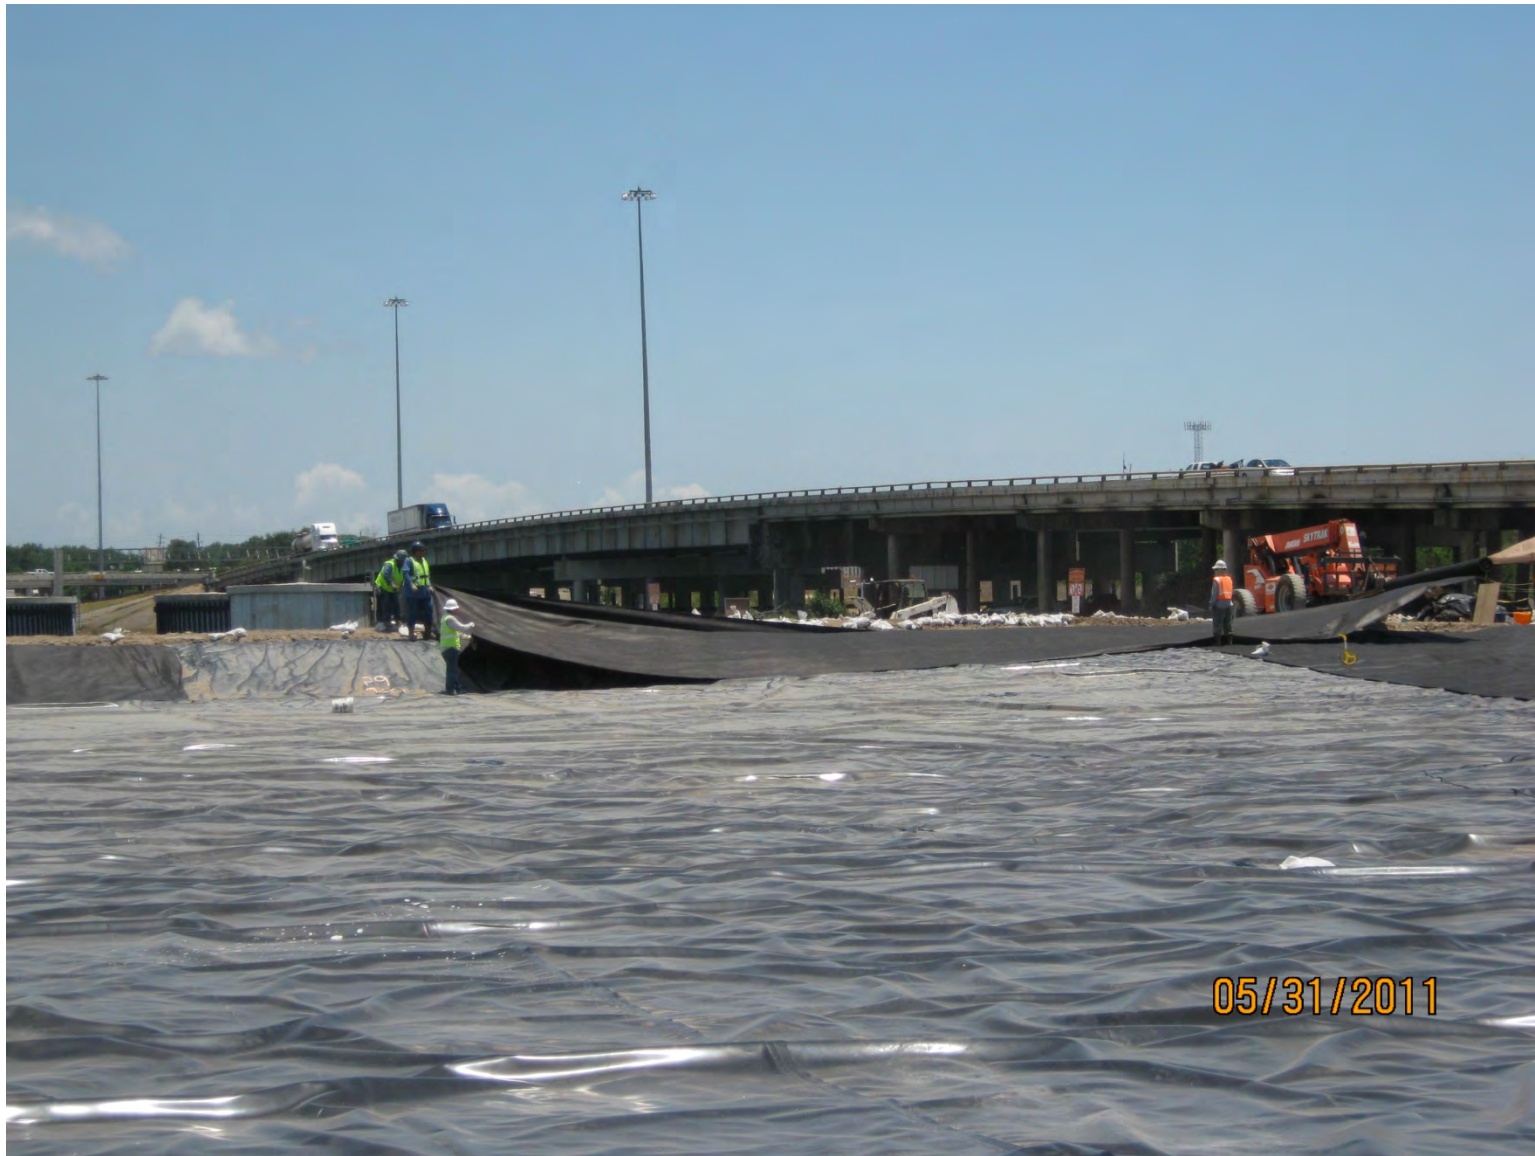
Protective cushion geotextile layer added over geomembrane. Looking southeast toward the stockpile area on the central berm.

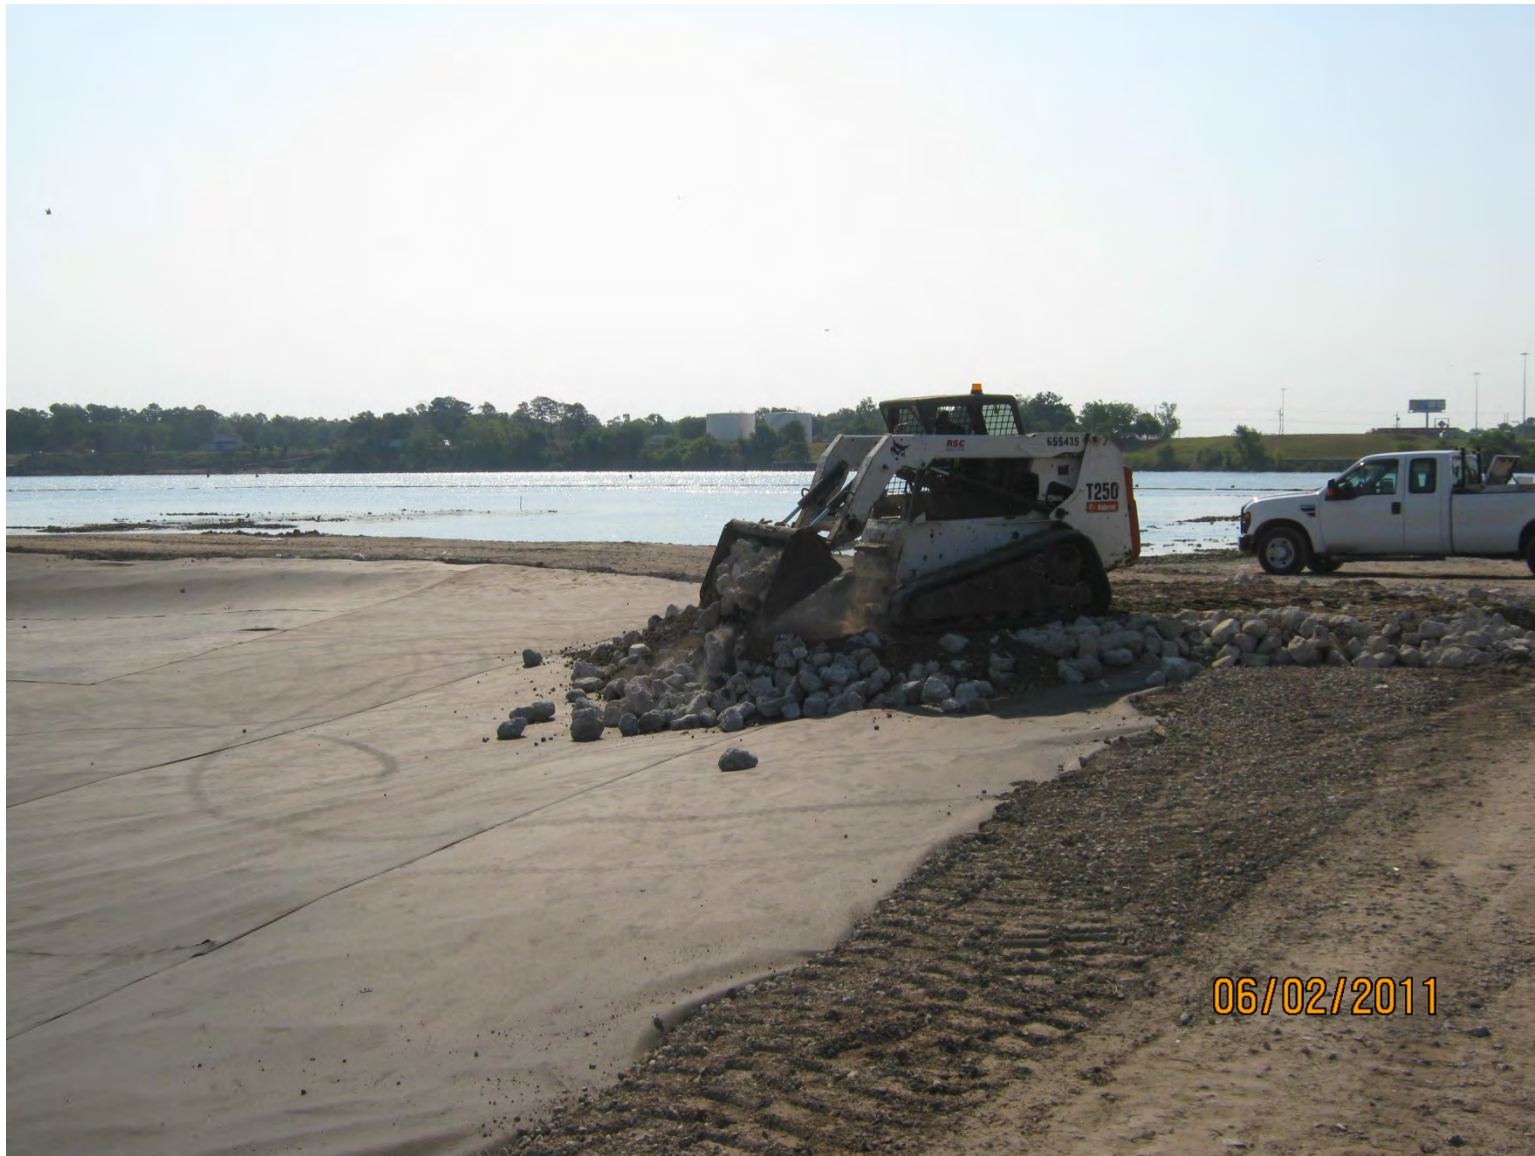
Stone placed atop second layer of geotextile at southeast corner of the western cell and the stockpile area. Note geomembrane trench.

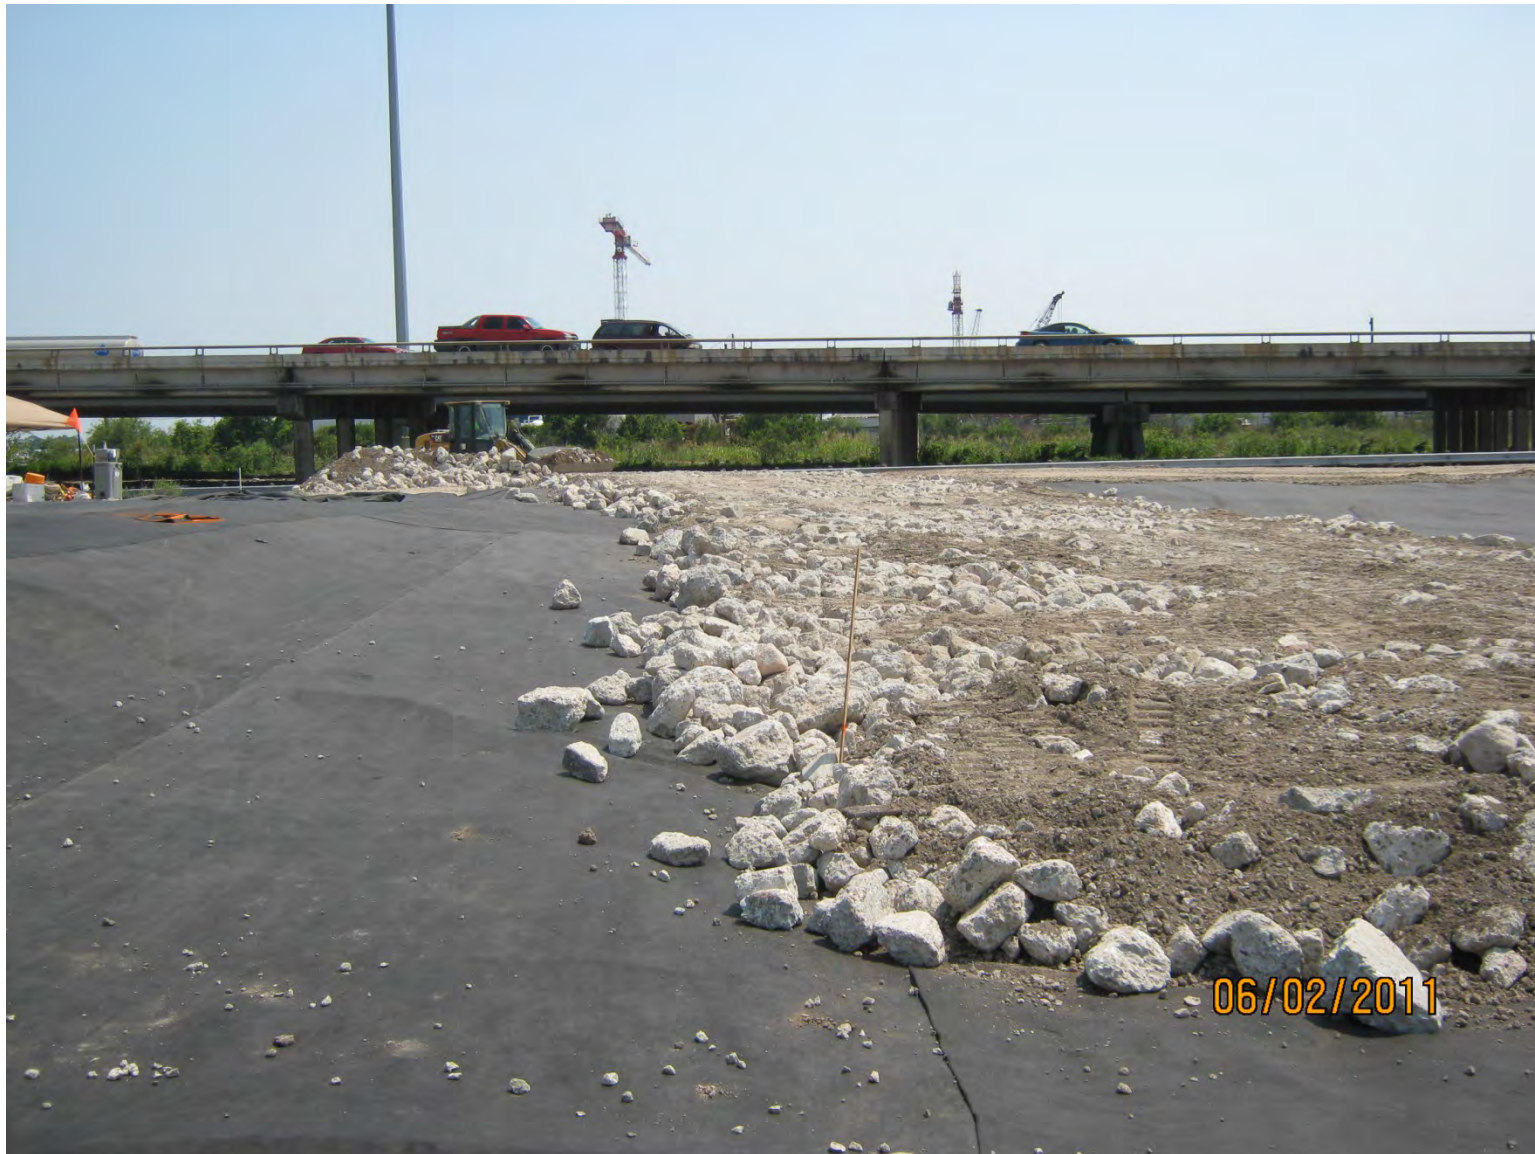
Armor stone being placed onto second layer of geotextile, looking south along central berm to the stockpile area.

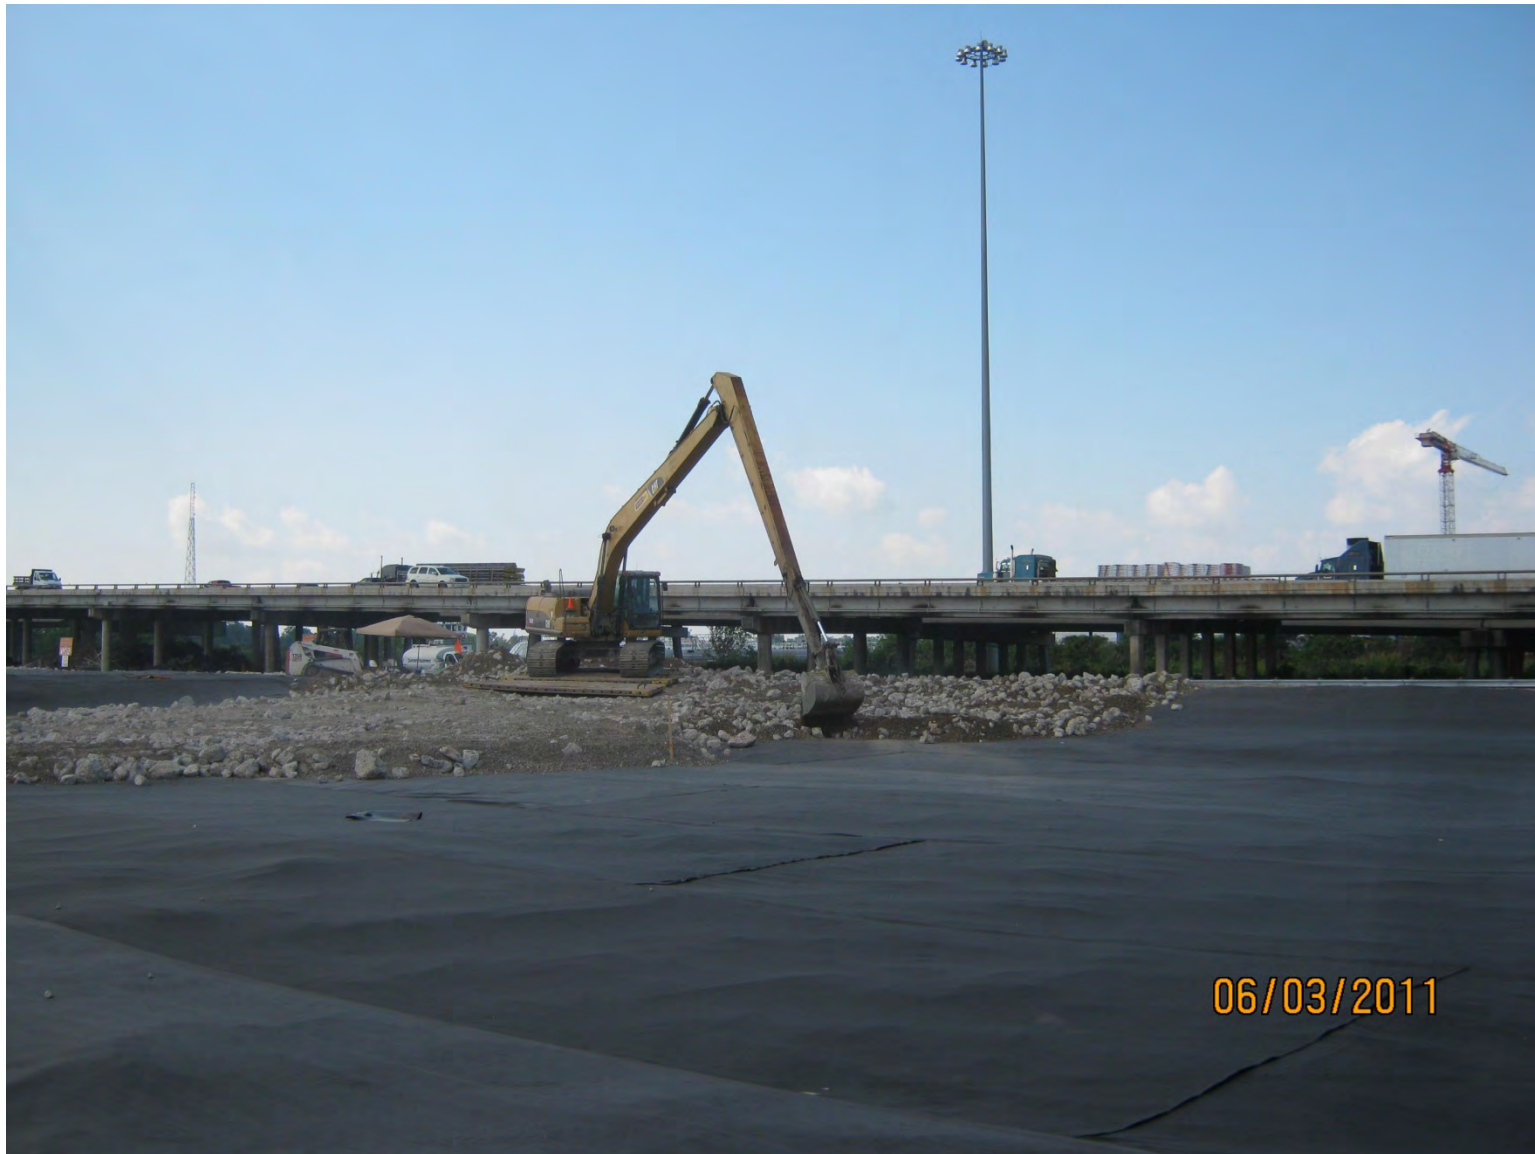
Excavator working from the stockpile area, placing armor stone on the second layer of geotextile. Photo looking south.

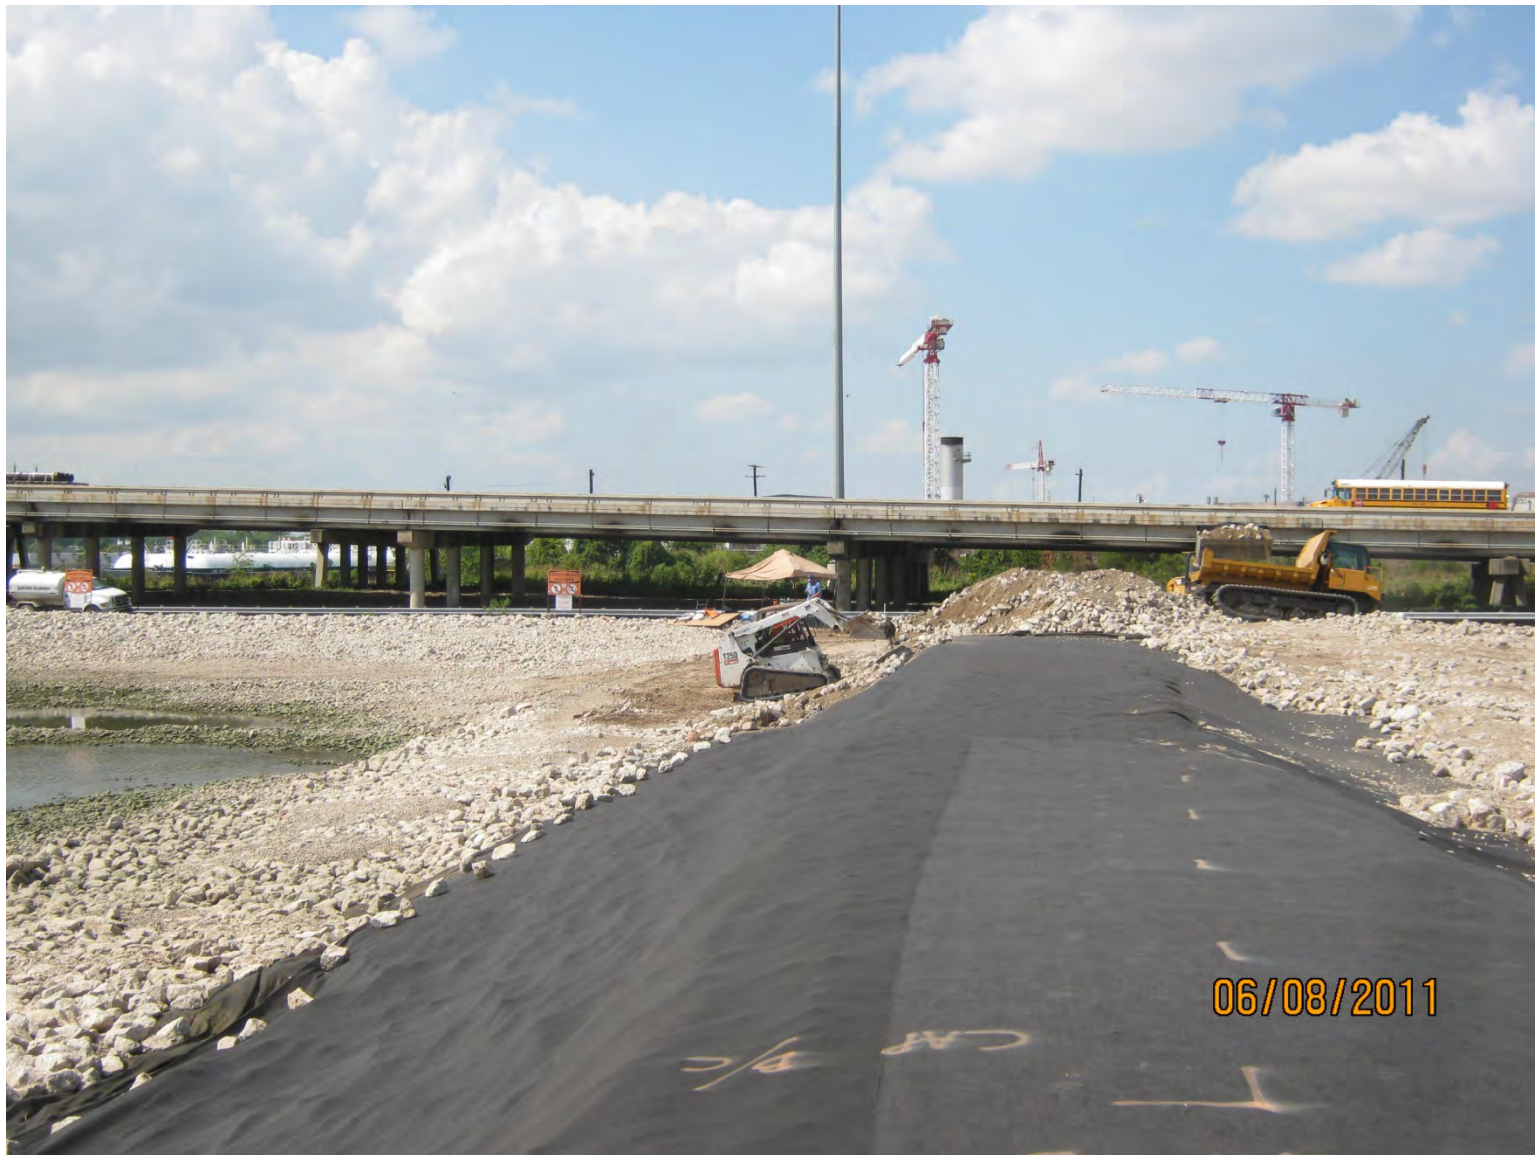
Geotextile and armor stone placed along central berm, look south toward the stockpile area.

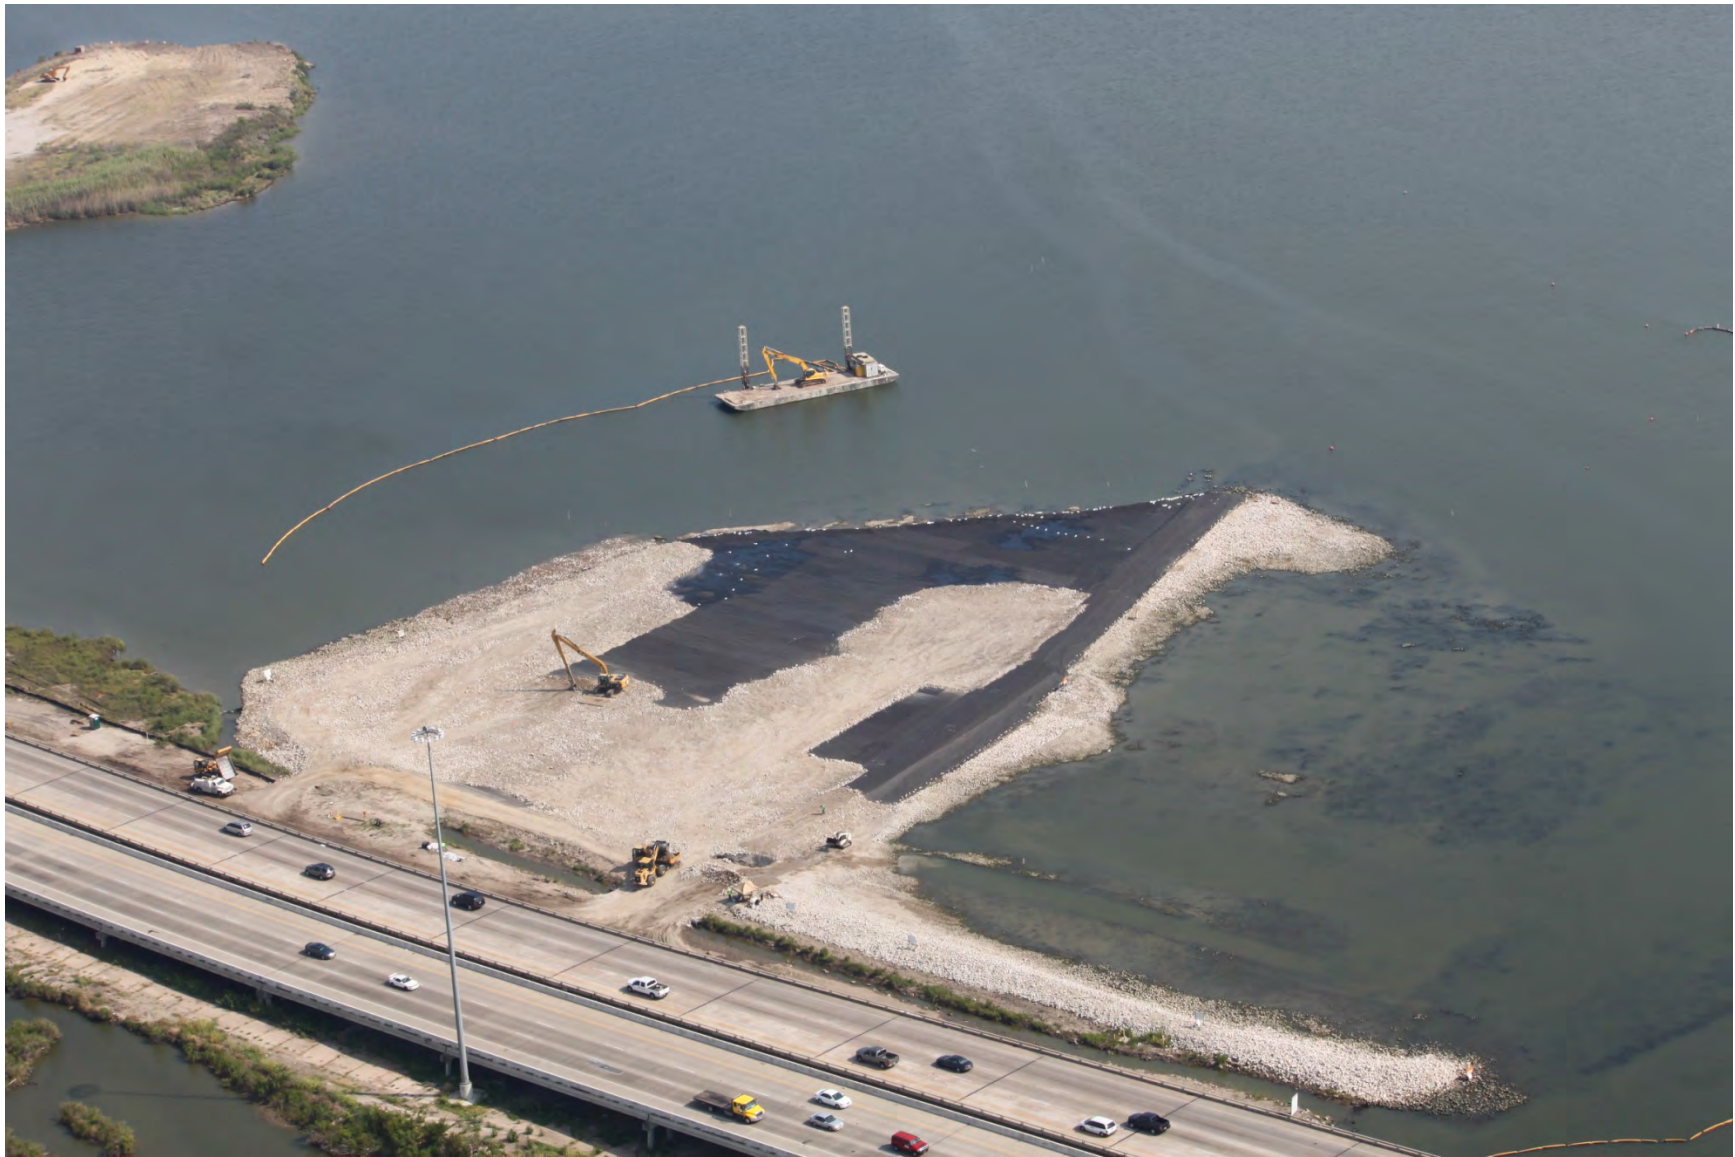
Project aerial photo dated June 9, 2011. Note geotextile over the geomembrane and stockpile area at juncture of central and southern berms.
